H AVAILABLE LITERATURE TRAILER SUSPENSION SYSTEMS

SUBJECT: Pivot-Connection Fastener
Information

LIT NO: L1072
DATE: April 2009

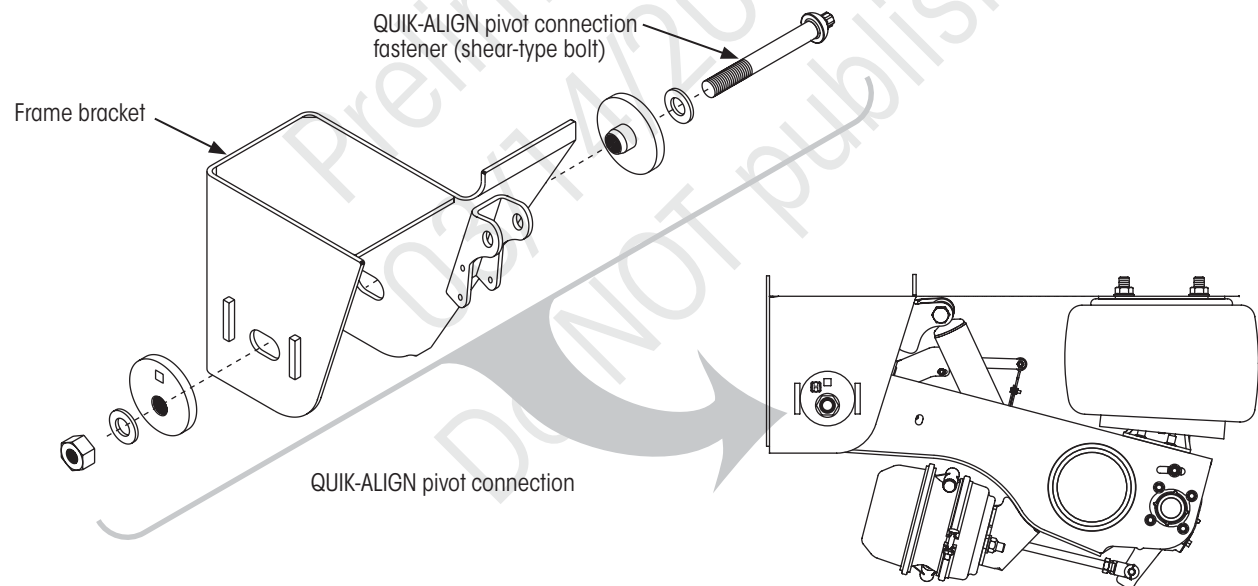
The QUIK-ALIGN® pivot connection fastener (or shear-type bolt) has been redesigned to help make the QUIK-ALIGN pivot connection tamper resistant.

The current bolt features a round head that helps to prevent reuse. Applying the proper torque and clamp force at the pivot connection is the same as it has always been. Simply install the bolt from the inboard side of the frame bracket and tighten with a Torx® socket until the bolt's Torx head shears off. To avoid damaging the splines on the shear bolt's Torx head, make sure the drive socket fully engages the Torx head.

The shear-type bolt may not be reused. Whenever the pivot connection is disassembled, the existing shear-type bolt must be removed by grinding or any other appropriate method and discarded, along with the existing hex nut. A new shear-type bolt and hex nut must be installed and sheared to achieve the proper pivot connection torque and clamp force. Anyone who assembles or reassembles the pivot connection (OEMs, dealers, repair facilities, etc.) is responsible for the proper installation of the shear-type bolt. Failure to reach the required torque can result in an insufficient clamp force, unreliable axle alignment, injury or property damage

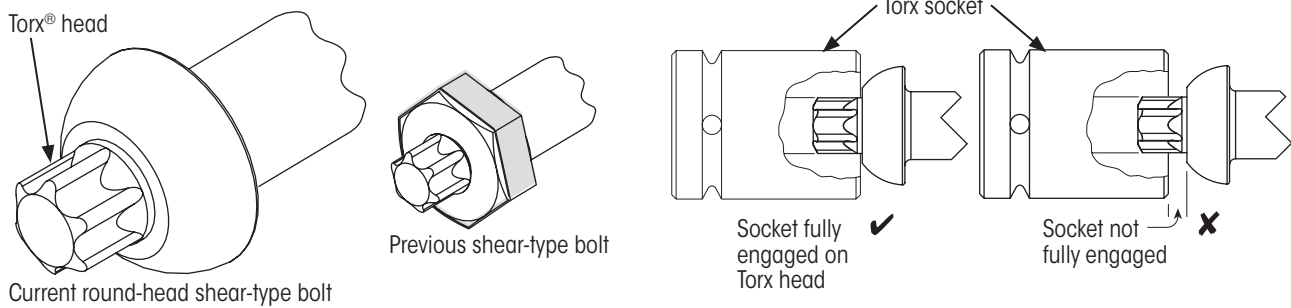
Hendrickson offers four Torx sockets that may be used during pivot connection assembly (refer to chart at left).
